Smoke and Dye Testing Summary

High Level Sewershed

Run Summary

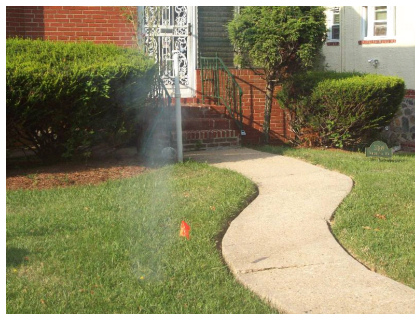
Picture \S1028-025-OB01-P01.jpg

Source Cleanout

Location Yard - front

Comments Smoke from cleanout, front yard of 3309 Dorchester Rd.

Comments Front of house, 3309 Dorchester

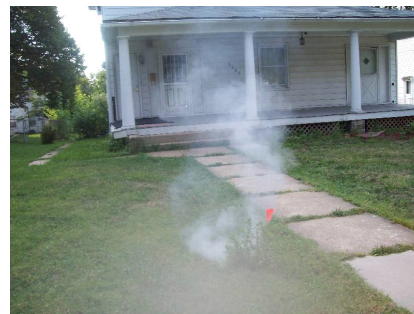
Picture \S1028-025-OB02-P01.jpg

Source Cleanout

Location Yard - front

Comments Smoke from cleanout in front yard. 3405 Hilton Rd.

Comments Front of house, 3405 Hilton Rd.

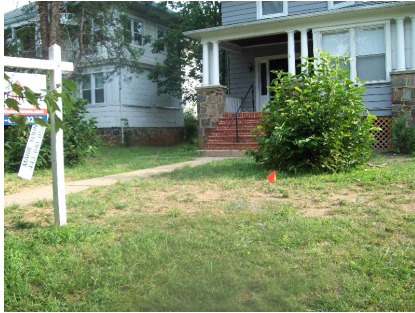
Picture \S1028-025-OB03-P01.jpg

Source Cleanout

Location Yard - front

Comments Smoke from cleanout in front yard. 3306 Egerton Rd.

Comments Front of house, 3306 Egerton Rd.

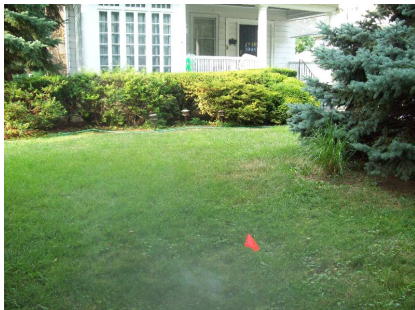
Picture \S1028-025-OB05-P01.jpg

Source Cleanout

Location Yard - front

Comments Smoke from cleanout in front yard. 3309 Egerton Rd.

Comments Front of house, 3309 Egerton Rd.

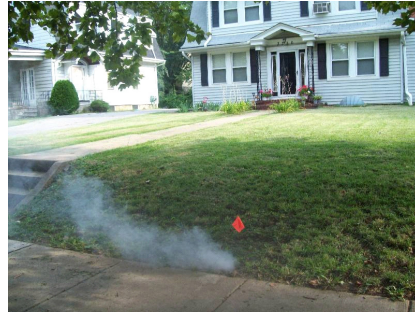
Picture \S1028-025-OB04-P01.jpg

Source Cleanout

Location Yard - front

Comments Smoke from cleanout in front yard. 3310 Egerton Rd.

Comments Front of house, 3310 Egerton Rd.

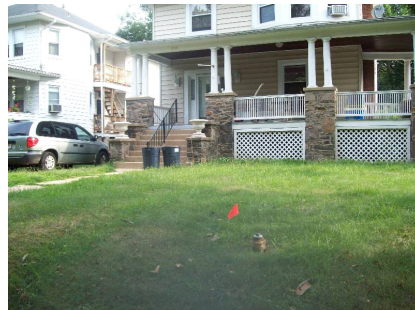
Picture \S1028-025-OB06-P01.jpg

Source Cleanout

Location Yard - front

Comments Smoke from cleanout in front yard. 3316 Egerton Rd.

Comments Front of house, 3316 Egerton Rd.
